Manhole Inspection Summary

Manhole # S35YY_033MH

Insp Date: **12/22/06 1:41 PM**

Location Address: **3220 GUILFORD AVE**

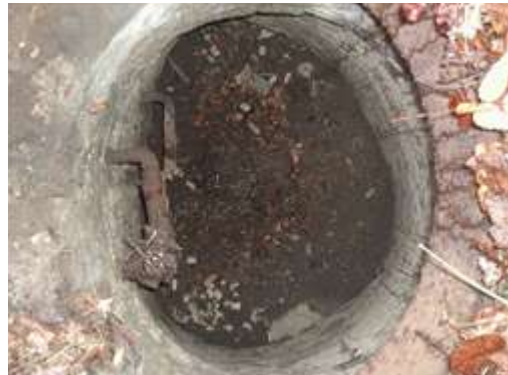
Top View

☒ **Debris** (not Condition related)

Count: **2** Missing: **0** ☒ **Corroded**

Corroded steps. Channel debris.

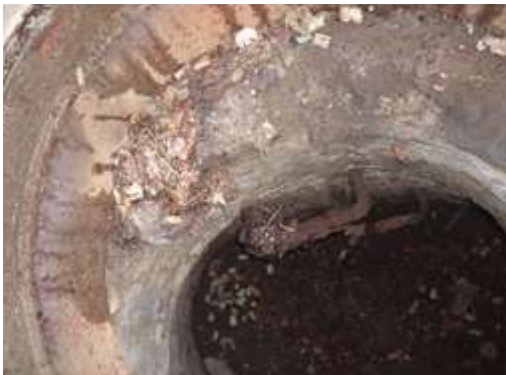
Defect

Offset: **7** (in.)

Condition: ☐ Sound ☐ Cracked ☐ Root Intrusion ☐ Loose Brick ☒ **Deteriorated**

Infiltration: ☐ None ☒ **Joint** ☐ Cracks ☐ Mortar ☐ Roots ☒ **Wall**

Frame offset. Adjustment deterioration and infiltration.

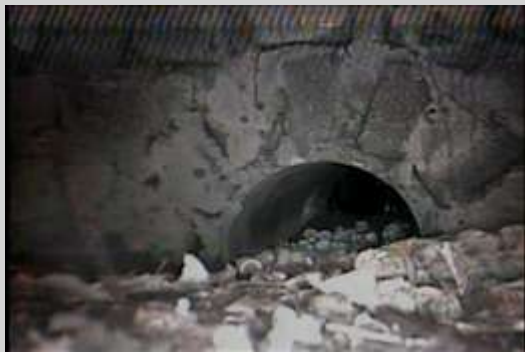
8 in. Circular Gravity Sewer
Pipe Out @ 12 O'Clock

Infiltration: ☐ None ☐ Joint ☐ Cracks ☒ **Mortar** ☐ Roots ☐ Wall

Barrel infiltration.

Deposits: ☐ None ☒ **Mud** ☐ Sludge ☒ **Debris** ☐ Grease

Silt Depth: **4** (in.) Deposits Extent: **Medium**
